EXAMINATION OF THE SURVEYOR 3
SURFACE SAMPLER SCOOP RETURNED
BY THE APOLLO 12 MISSION

R. F. Scott and K. A. Zuckerman

1971

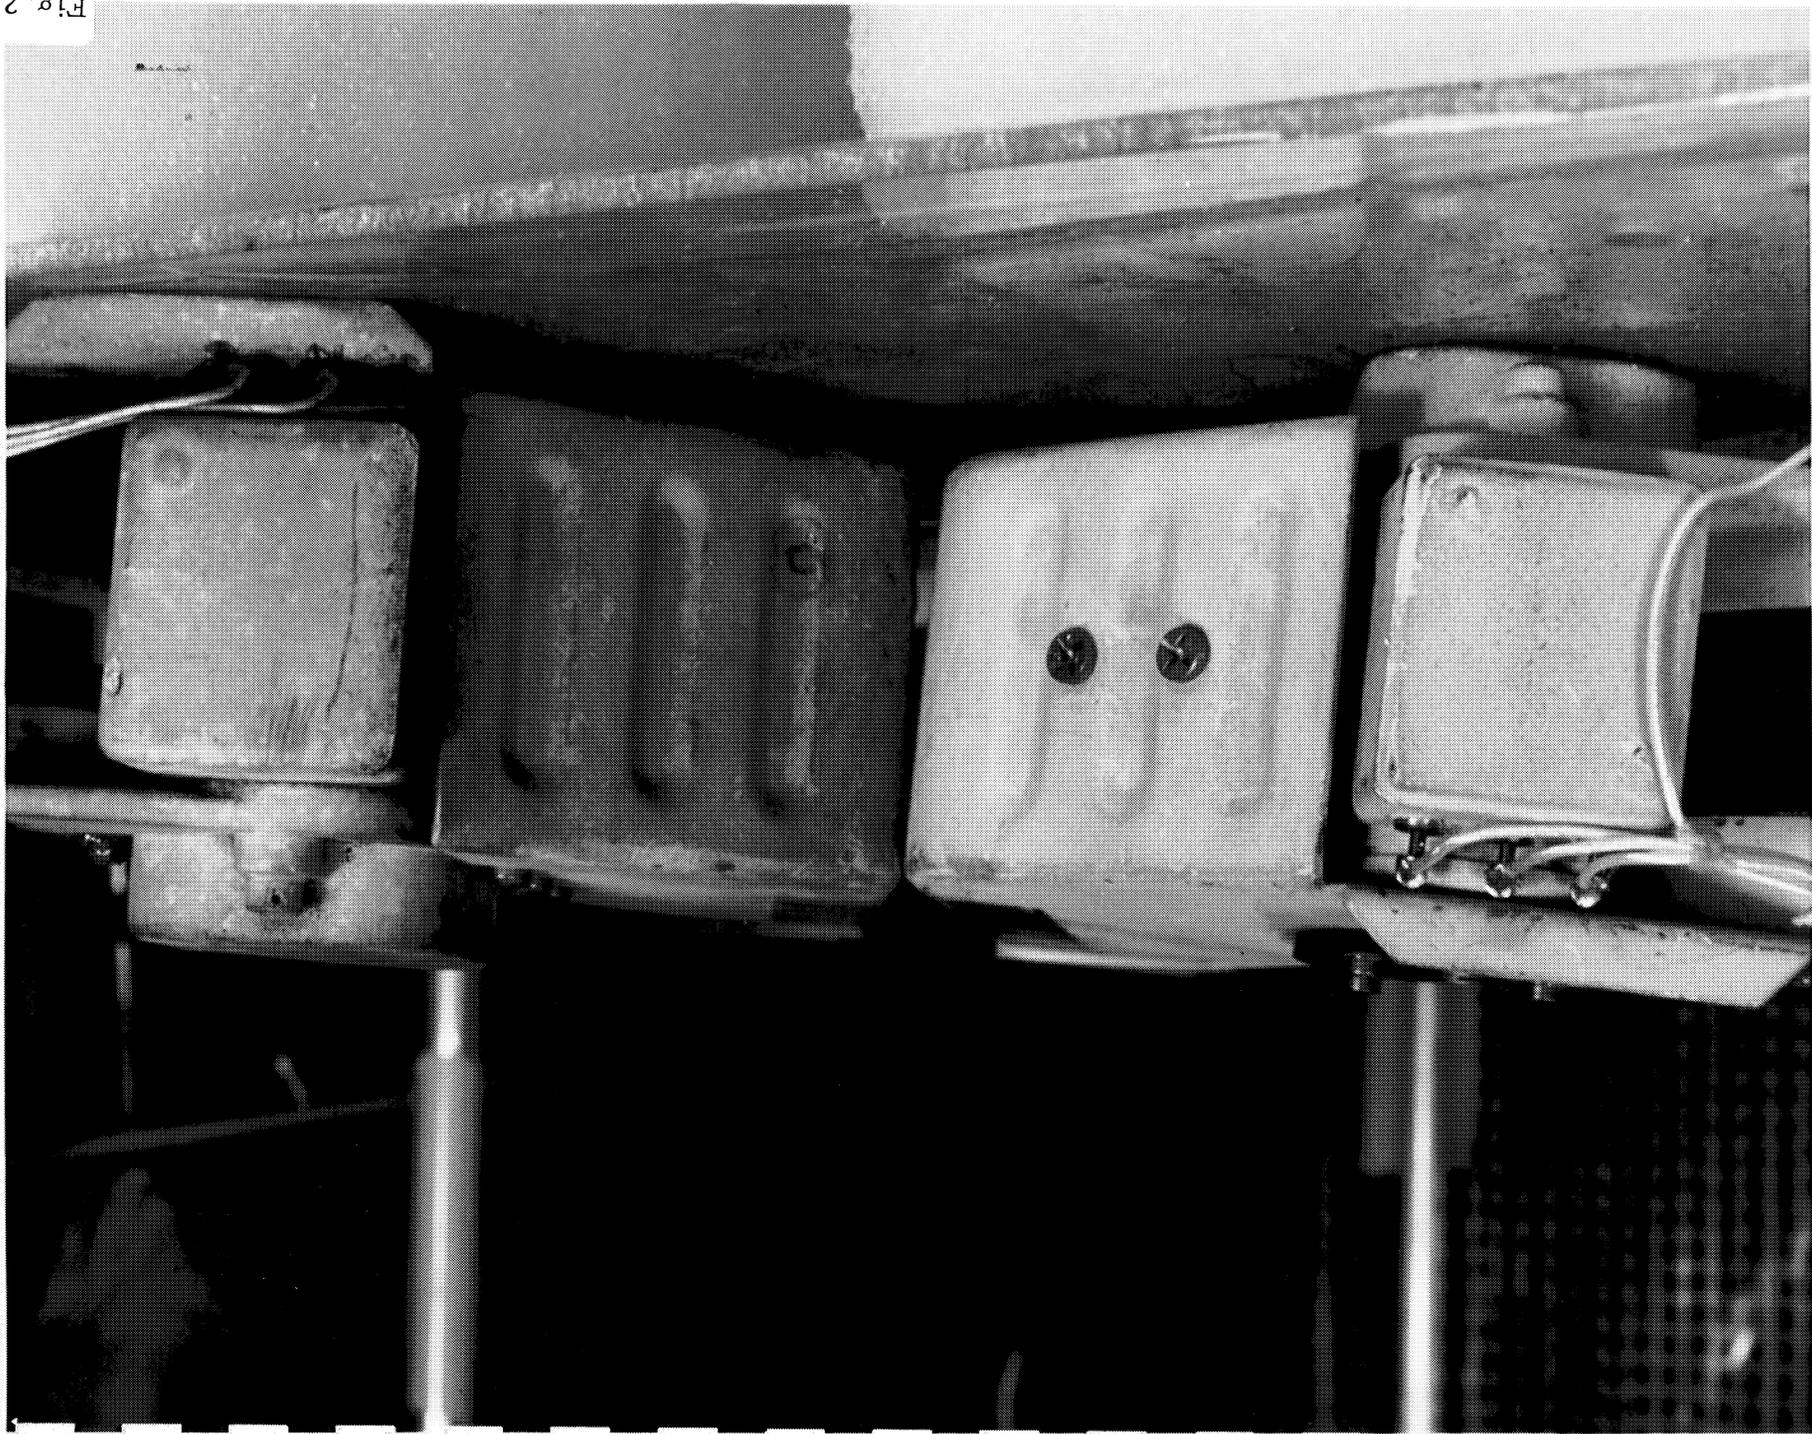
Fig. 21

pattern is also apparent in varying degrees under different lighting conditions in Figs. 17 (infra-red), 19 (ultraviolet), 21(UV), 22(UV) and 24 (UV). To some extent, the patterns of color change can be correlated with the extent to which the scoop was covered with lunar soil before it was touched by the astronauts. On the right-hand side of the scoop a comparison of Figs. 3 (taken by the astronauts) and 7 clearly indicates that the bottom portion of the scoop side which was covered with lunar soil has not changed in color to the same extent as the rest of the scoop. This would seem to indicate that the color change process is related to the irradiation of the painted surface. It can be seen in Figs. 20 and 21 that the top of the scoop also has a blotchy appearance; the tan color is lighter inside the blotches. In this area, the effect again appears to be related to a protective covering of soil clumps or aggregates as can be seen by comparing Figs. 20 and 21 with the Surveyor 3 photograph, Fig. 2.
